ORDINANCE NO. 12-2018

**AN ORDINANCE OF THE VILLAGE OF EVERGREEN PARK
DESIGNATING THE EVERGREEN PLAZA TOWERS
PROPERTY LOCATED AT 9730 SOUTH WESTERN AVENUE
(P.I.N. 24-12-236-005-0000), IN THE VILLAGE OF EVERGREEN
PARK, COOK COUNTY, ILLINOIS AS BLIGHTED**

RE: Evergreen Plaza Parking Garage
Condition Evaluation Peer Review
Carl Walker, Inc. Project No. R1-2016-121

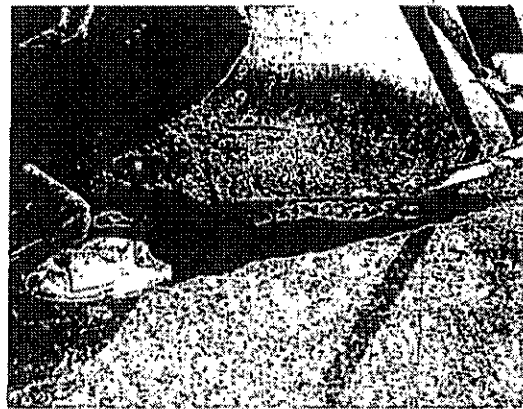
The roof level floor exhibited several delaminations and one full depth hole. We also noted widespread cracking in the floor surface.

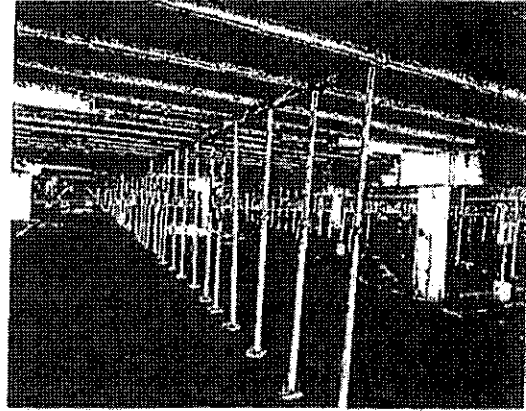
At the lower level, post shores were installed at midspan beneath most of the concrete joists.

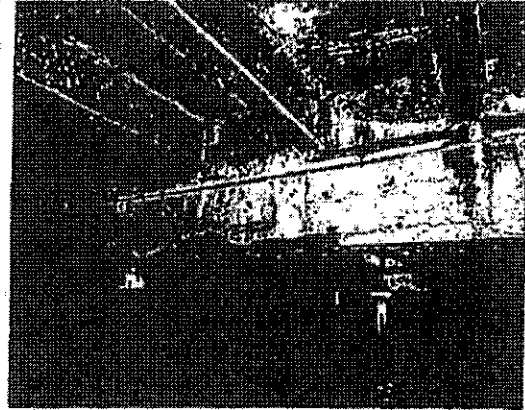
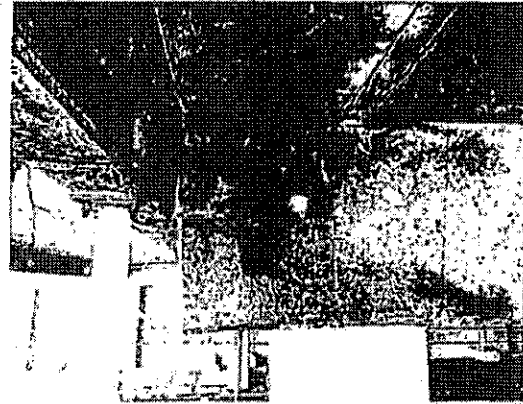
A few of the concrete beams exhibited large areas of concrete delamination / spalling. One beam exhibited deterioration at the bearing where the post-tension anchors are located. Based on the observed deterioration, we believe that there is a potential for post-tension tendon distress within the beams.

Additional investigation would be required to determine the extent of potential beam post-tension tendon deterioration prior to any decision to re-use the beams can be made.

3. Based upon observed deterioration in the existing post-tension beams, we do not recommend re-using the existing beams. Although the beams could be analyzed and likely repaired, the repaired beams should be anticipated to have a shorter life expectancy than a replacement floor.

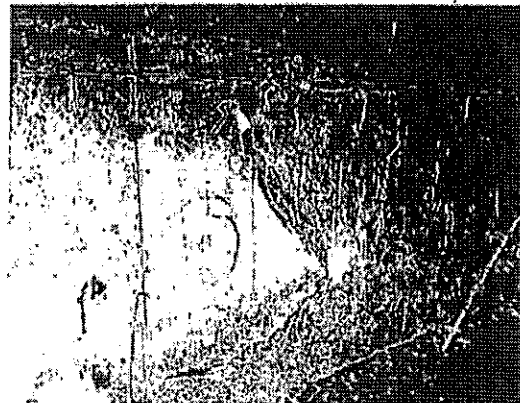
The columns and perimeter walls exhibit minimal concrete deterioration at isolated locations.
