ORDINANCE NO. 12-2018

**AN ORDINANCE OF THE VILLAGE OF EVERGREEN PARK
DESIGNATING THE EVERGREEN PLAZA TOWERS
PROPERTY LOCATED AT 9730 SOUTH WESTERN AVENUE
(P.I.N. 24-12-236-005-0000), IN THE VILLAGE OF EVERGREEN
PARK, COOK COUNTY, ILLINOIS AS BLIGHTED**

RE: Evergreen Plaza Parking Garage
Condition Evaluation Peer Review
Carl Walker, Inc. Project No. R1-2016-121

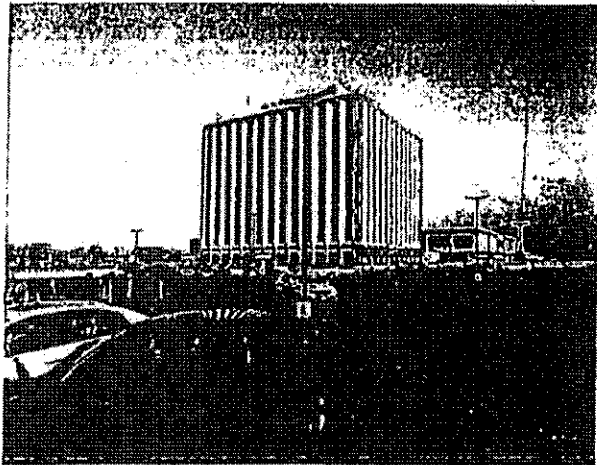
The Evergreen Plaza Parking Garage, originally constructed in the late 1960s, is a single supported level, at-grade, cast-in-place concrete parking structure located at 9730 S. Western Avenue in Evergreen Park, Illinois.

In 2014, the condition of the parking garage was evaluated by SSE. Their evaluation included: site observations of existing conditions, ground penetrating radar (GPR) and test excavations to verify existing reinforcement in the slab and joists, concrete compression testing, chloride ion testing, and structural calculations. Their May 8, 2014 report concluded that due to deterioration and construction deficiencies the upper level floor system was overstressed and not capable of supporting the design loads. They recommended closing the lower level and shoring the upper level until repairs are completed. SSE provided two repair recommendations: Option 1 to replace the entire existing concrete deck (and joists) for an estimated price of \$4,250,000, or Option 2 to replace existing concrete joists with steel joists and localized slab replacement for an estimated costs of \$3,325,000.
